Liffey Valley to City Centre Core
Bus Corridor

Desktop Safety Review

Document Ref:	P18-083-PSW1-RP-001
----------------------	----------------------------

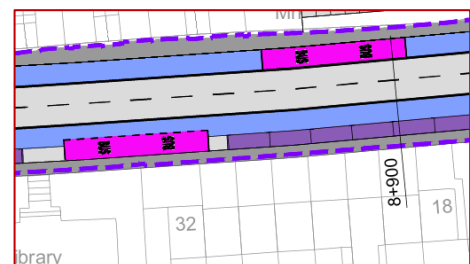
Summary: Unclear if adequate footpath width is proposed at all locations along the route, and in particular at proposed bus stop locations.

It is unclear from the information provided whether adequate footpath width is proposed at all locations along the route. In particular at proposed bus stop locations where waiting bus passengers, bus shelters and signage (e.g. RTPI signs) may reduce the effective footpath width.

Ensure that adequate footpath width has been provided at all locations along the route to cater for the expected volumes of pedestrians and taking account of the likely items of roadside furniture to be provided (e.g. bus shelters, signage, etc.).

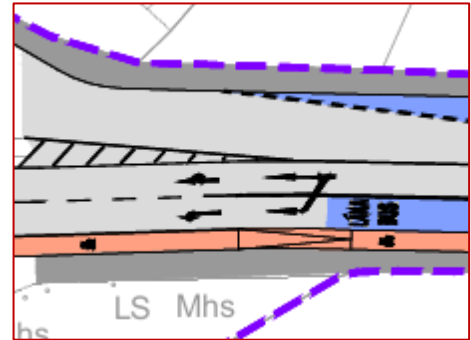
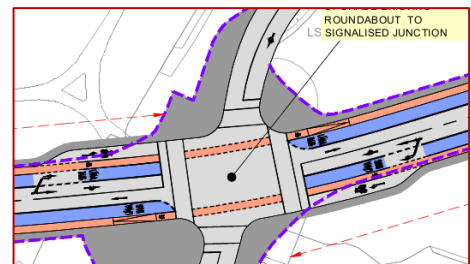
Two different junction treatments are proposed throughout the project to cater for left-turning vehicles. One of the proposed arrangements consists of developing a dedicated left-turn lane on the nearside of the straight-ahead cycle lane, with left-turning cyclists and vehicles sharing this lane.

The alternative arrangement consists of left-turning drivers turning across the cycle lane from the bus lane. This proposed layout presents a particular risk to cyclists wishing to proceed straight-ahead or turn right at the junction.

The lack of consistency in the junction layouts along the bus corridor route could lead to inappropriate, or unsafe, manoeuvres by left-turning drivers, in particular those unfamiliar with the route.

Adopt and implement a consistent layout at the junctions along the route. Should the chosen layout consist of left-turning vehicles crossing the straight-ahead cycle lane then measures will be required to ensure that cyclists are not put at risk of being struck by turning vehicles. Some guidance is available in Section 4.5 of the National Cycle Manual.

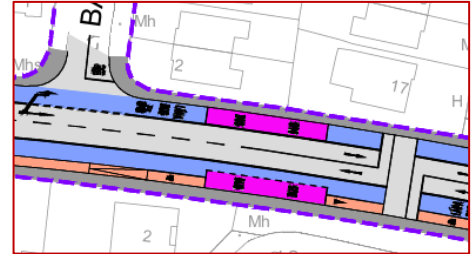
Location: Drawing Sheet 1 - Ballyowen Road

Summary: Proposed location of bus stop may impede visibility for drivers exiting from nearby side road and/or impede visibility for drivers approaching the signalised pedestrian crossing immediately downstream.

A bus stop is proposed on the northern side of the Ballyowen Road, east of Ballyowen Drive. There is a risk that stationary buses at this bus stop could impede visibility to the left for drivers exiting from Ballyowen Drive, resulting in unsafe exiting manoeuvres and side-on collisions.

In addition, stationary buses at this bus stop may impede visibility of eastbound drivers in the adjacent traffic lane towards the signals at the pedestrian crossing immediately downstream, resulting in approaching drivers being unaware of the need to stop, leading to a failure to stop and overshoot into the crossing resulting in possible vehicular/pedestrian collisions.

Relocate the proposed bus stop.

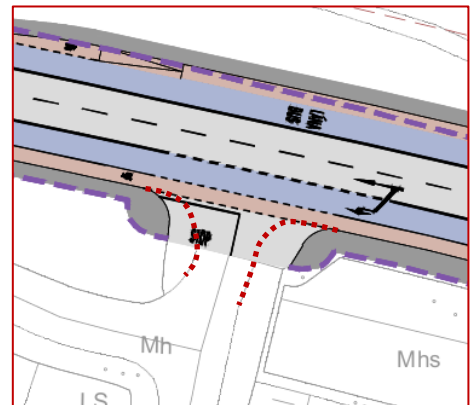
Location: Drawing Sheet 1 - Ballyowen Road & Larkfield Avenue Junction

In addition, the proposed layout does not tie in with the existing footpaths on Larkfield Avenue, which will require pedestrians to enter the carriageway as they travel to/from Larkfield Avenue and the Ballyowen Road.

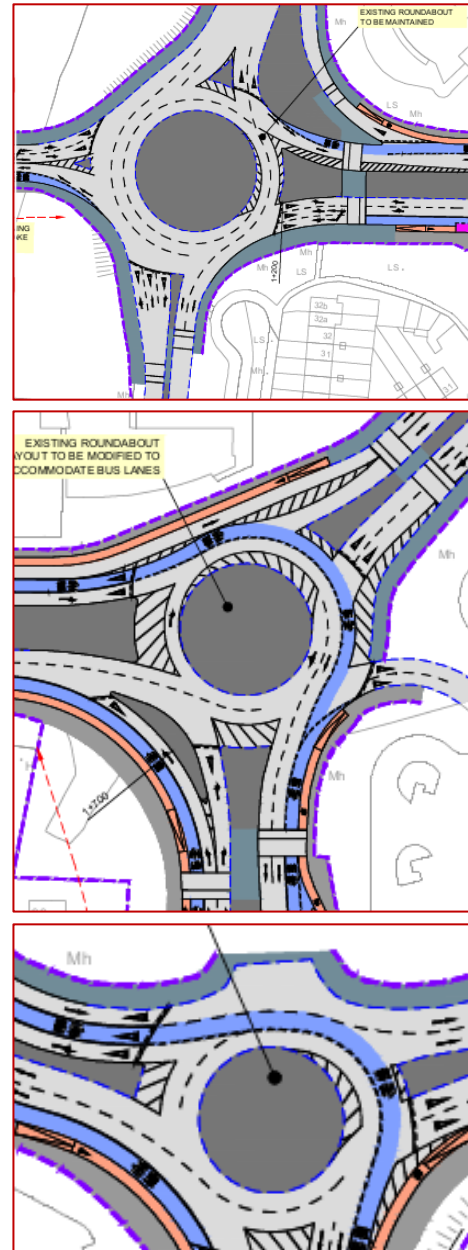
Location: Drawing Sheets 4, 5, 6 & 7 – Roundabout Junctions

The introduction of a third lane, e.g. bus lane, on existing two-lane roundabouts also increases the complexity for drivers with a resulting increased likelihood of inappropriate or unsafe lane-change manoeuvres on the entry or exit of these roundabouts leading to side-swipe collisions with vehicles in the adjacent lane.

The proposed location of pedestrian or toucan signalised crossings immediately downstream from the roundabout exits could result in drivers, particularly those on dedicated left-turn lanes at the roundabouts, being insufficiently aware of the upcoming crossing as their attention would have been focused on other traffic as they exit the roundabout, leading to a failure to stop, overshoot incidents and possible collisions with crossing pedestrians.

In addition, the retention of these roundabout junctions is inconsistent with the proposed treatment elsewhere along the route, both to the west and east, where existing roundabouts are proposed to be replaced by signalised junctions.

Provide signalised junctions at these locations.

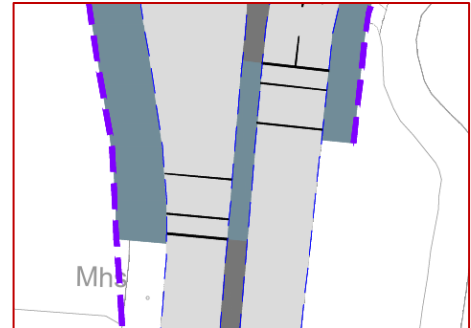
Insufficient width of refuge can increase the likelihood of pedestrians or cyclists within the refuge being struck by part of a passing vehicle.

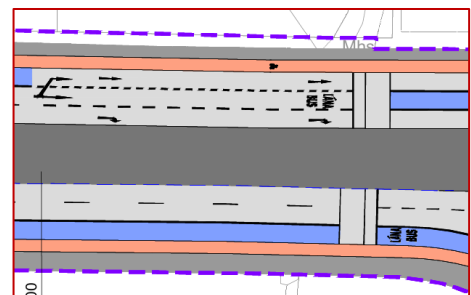
The length of this weaving section is relatively short, and it is located on the immediate approach to a pedestrian crossing.

Drivers undertaking weaving manoeuvres may be insufficiently aware of the status of the signals at the pedestrian crossing, resulting in a failure to stop leading to overshoot incidents and collisions with crossing pedestrians.

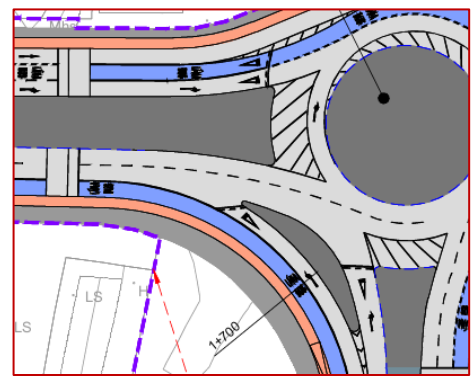
Drivers exiting from the left-turning lane will have their focus primarily to the right, towards other vehicles exiting from the nearby roundabout, and may be insufficiently aware of the status of the signals at the pedestrian crossing resulting in a failure to stop and overshoot into the crossing, leading to vehicular/pedestrian collisions.

Either relocate the signalised pedestrian crossing so that there is a greater distance between the left-turning lane and the crossing to allow drivers sufficient distance/time to be sufficiently aware of the crossing, or replace the proposed roundabout junction with a signalised junction with the pedestrian crossings incorporated into it.

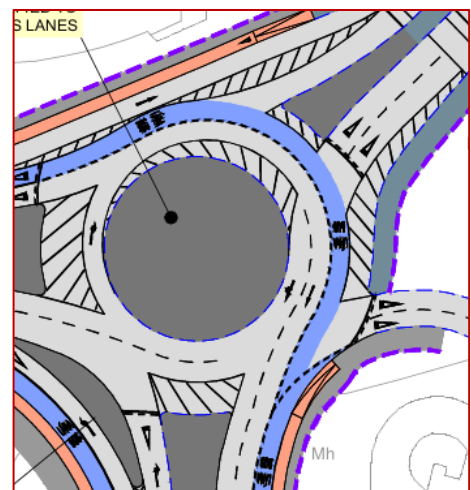
Summary: Hatched roadmarkings at roundabout junction will fade over time rendering the layout indistinct leading to unsafe manoeuvres and collisions.

These hatched markings will fade/wear-off over time, and the layout may become indistinct and insufficiently clear, resulting in unsafe manoeuvres and side-swipe collisions.

Amend the proposed junction layout to replace at roadmarkings with kerbed build-outs/islands.

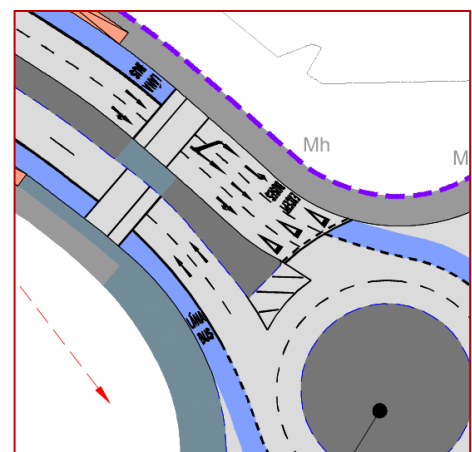
Signalised pedestrian crossings have been indicated immediately downstream of a number of roundabouts within the Liffey Valley area.

The proximity of these signalised crossings to the roundabouts could result in queues at the signalised crossings extending back into the upstream circulating carriageway, leading to congestion and obstructions to drivers attempting to enter the roundabout from the other arms. This could lead to driver frustration and rash/unsafe manoeuvres.

If the signalised pedestrian crossings were located to points further downstream of the roundabout exits, this could address this issue, but the crossings may then no longer be on the likely pedestrian desire line resulting in unsafe pedestrian crossing.

Therefore, it is recommended that the roundabouts be replaced by signalised junctions with pedestrian crossings incorporated within them.

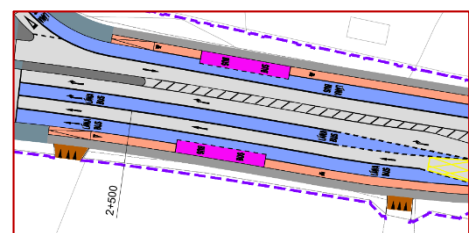
The number of different lanes developed over this short section is likely to lead to driver confusion and late lane-change manoeuvres resulting in possible side-swipe collisions.

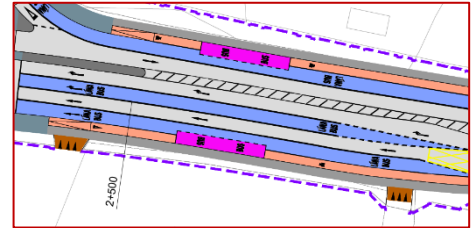
Summary: Unsafe manoeuvres arising from driver frustration showed queuing vehicles from signalised junction block straight-ahead traffic.

Queuing vehicles at the signalised junction may extend back to the overbridge and block access to the straight-ahead lanes, which could give rise to straight-ahead drivers entering the adjacent cycle track or placing two wheels on the kerb in order to pass queuing vehicles in order to enter the straight-ahead lanes.

These manoeuvres could result in collisions with vulnerable road users on the adjacent footpath, shared-use path or cycle track.

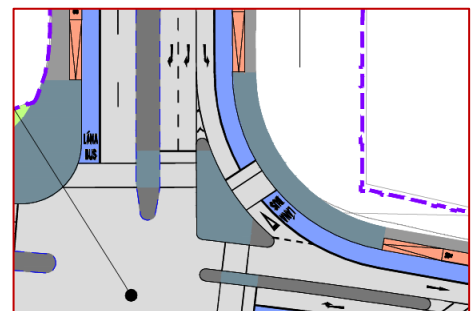
Should no lane widening be provided there is a risk that the lanes will be insufficient to accommodate the swept path of large vehicles/buses, resulting in encroachment into the adjacent lane and possible side-swipe collisions with vehicles in the adjacent lane.

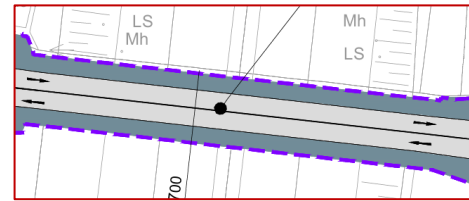
It is unclear if the existing parapets on the Coldcut Road overbridge, which crosses over the M50, are adequate for the amended road layout/use, for example capable of restraining an errant bus or of a height to restrain an errant cyclist.

These should be reviewed during the design development and if necessary replaced with appropriate parapets.

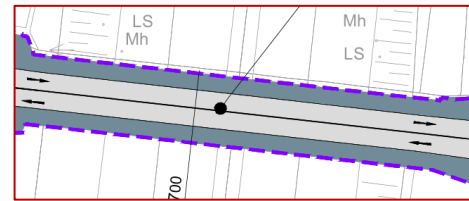
It is unclear if the existing Coldcut Road overbridge is of adequate width to accommodate the proposed road layout, in particular the shared-use paths on either side of the bridge, once the existing/future road side furniture (e.g. public lighting columns) is taken into account.

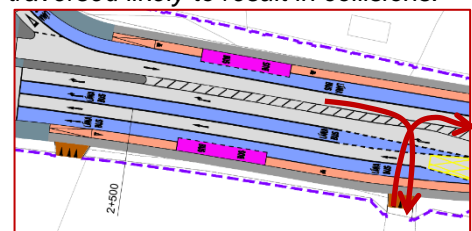
Two private accesses have been indicated on the southern side of the Coldcut Road where a relatively complex road layout is proposed. Vehicles attempting to turn right into, or right out of, these accesses will have to cross a cycle lane, two bus lanes & two traffic lanes.

These manoeuvres would be difficult to complete due to the number of different traffic streams a right-turning driver would have to be aware of, and take account of, in order to complete this manoeuvre safely.

Replace the proposed hatching between opposing traffic directions on this section of Coldcut Road with a solid island, and limit access/egress to/from these private accesses to left-in or left-out only.

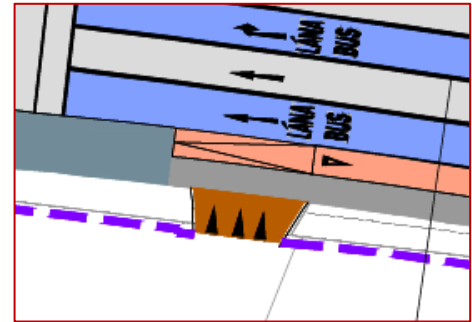
A private access has been indicated at the same location where a proposed cycle facility transitions from an on-road cycle lane to an off-road shared-use facility, immediately east of the Liffey Valley/Coldcut Road junction. This will result in vehicles entering/exiting from this private access traversing a section of carriageway with varying height kerbs.

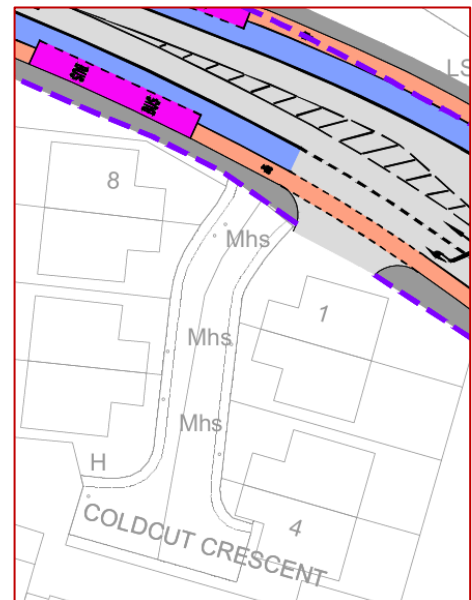
Summary: Stationary buses at proposed bus-stop may block visibility for exiting side road drivers resulting in unsafe exiting manoeuvres and side-on collisions stop

The access to Coldcut Crescent is shown incorrectly on the drawings provided. When this junction location is corrected, presumably during subsequent design development phases, the location of the proposed bus stop could result in stationary buses at the bus stop blocking visibility for drivers exiting from Coldcut Crescent and wishing to turn right onto Coldcut Road, leading to unsafe exit manoeuvres and possible side-on collisions.

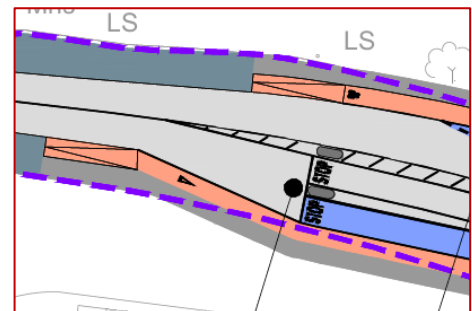
Summary: Buses encroaching into cycle lane will present hazards to cyclists.

There is a risk that buses proceeding west from the bus gate may cut across the corner at this transition, encroaching into the cycle facility and presenting a hazard to cyclists.

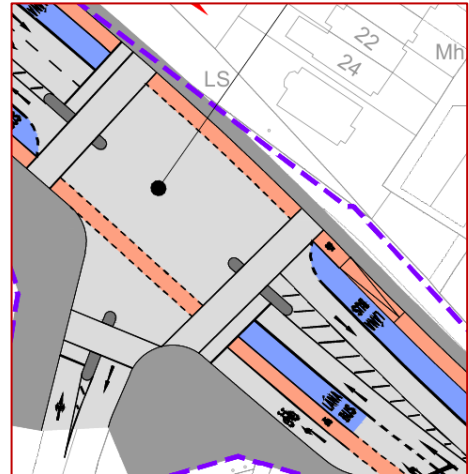
Pedestrians could become stranded mid-crossing may attempt to complete the crossing outside of the dedicated pedestrian phase, with a resulting risk of being struck by a vehicle or cyclist.

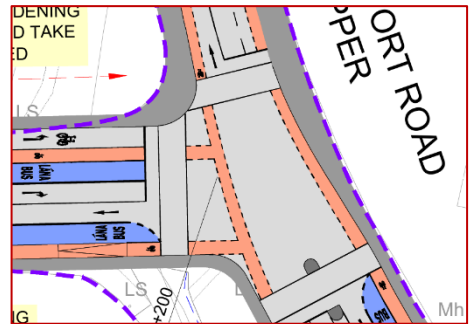
An absence of guidance markings for these right-turning lanes could result in some drivers drifting into the adjacent lane leading to side by side collisions.

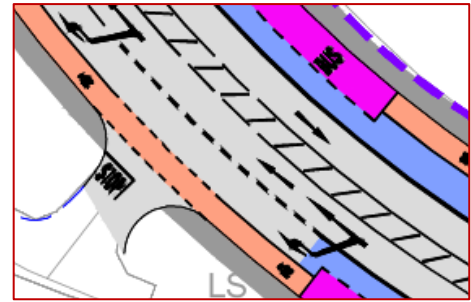
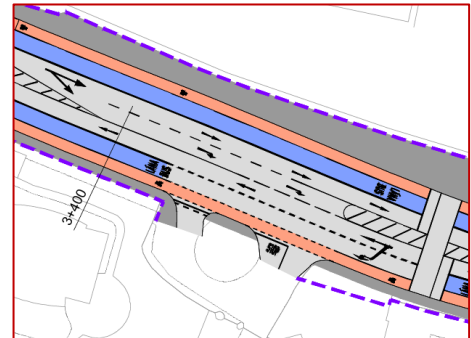
Summary: Right-turning manoeuvres from priority junctions where drivers are required to cross multiple bus, traffic & cycle lanes could result in unsafe exiting manoeuvres and side-on collisions.

Drivers exiting from these side roads wishing to turn right will have to cross multiple lanes, including cycle lanes. It will be difficult for right-turning drivers to identify safe gaps in the approaching traffic in order to complete a right-turning manoeuvre, possibly leading to unsafe manoeuvres and side-on collisions.

In addition, exiting drivers from the hospital entrance wish to turn right may be insufficiently aware of the status of the signals at the signalised pedestrian crossing immediately downstream of the entrance, resulting in overshoot into the crossing and possible collisions with pedestrians.

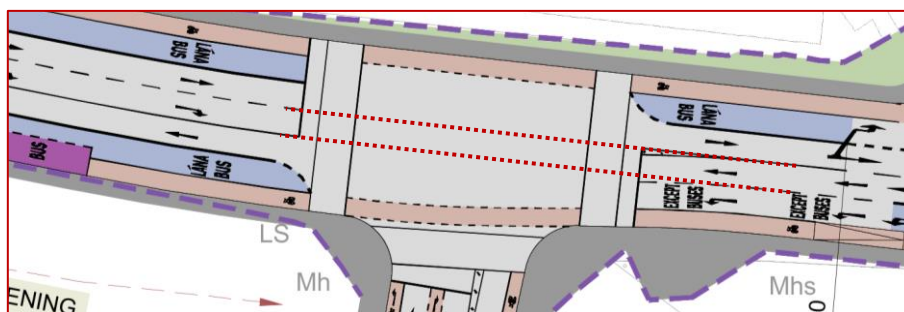
The straight-ahead lane on Ballyfermot Road westbound at the junction with the entrance to Cherry Orchard Hospital is in line with the eastbound right-turning lane. This could result in westbound drivers inadvertently entering the opposing right-turn lane leading to late correction manoeuvres and side-swipe collisions, or to log-speed head-on collisions with oncoming vehicles.

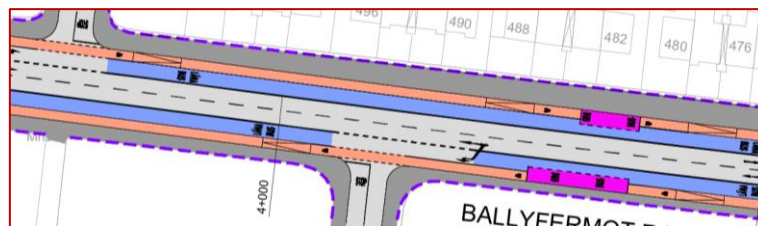
Summary: Absence of controlled pedestrian crossing at location where likely pedestrian desire line across Ballyfermot Road will exist could lead to uncontrolled crossings and vehicular/pedestrian collisions.

No pedestrian crossing has been indicated in the vicinity of the Ballyfermot Road/Blackditch Road junction. There is a likely pedestrian desire line to cross Ballyfermot Road at this location, given the proximity of the side roads to the north and south of Ballyfermot Road and the proposed bus stops nearby.

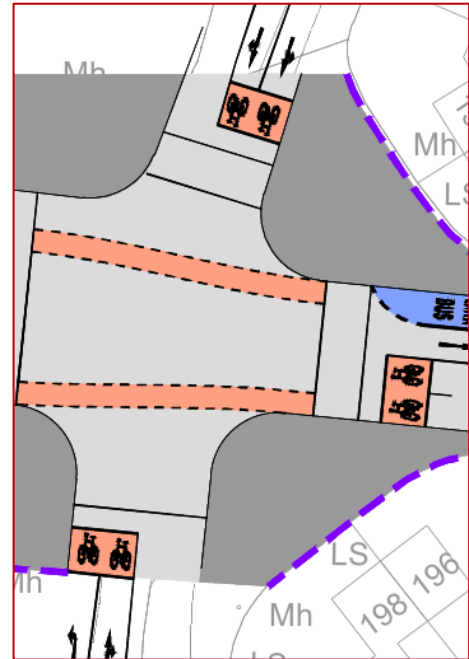
This could result in side-swipe collisions as two traffic lanes attempting to merge into a single traffic lane on the exit from the junction.

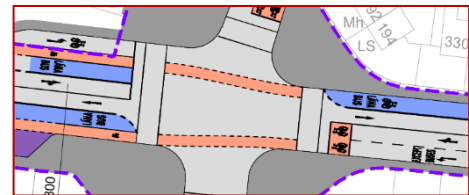
Right-turning vehicles on either approach will impede straight-ahead traffic, resulting in straight-ahead traffic entering the adjacent left-turning or bus lane leading to possible side-swipe collisions.

In addition, right-turning drivers will now need to identify a gap in multiple approach lanes (e.g. westbound right-turning traffic will need to identify gaps in the opposing straight-ahead traffic lane, bus lane, cycle lane and left-turning lane). This may prove difficult to achieve, leading to driver frustration and rash manoeuvres resulting in side-on collisions.

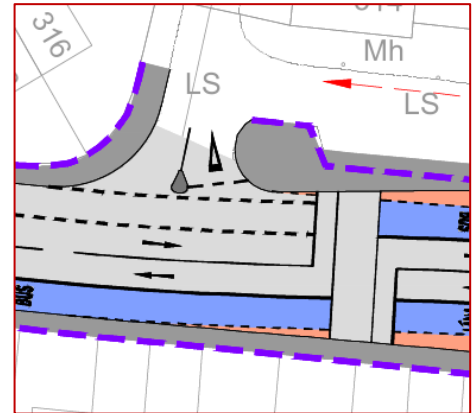
The proximity of the signalised pedestrian crossing to the east of the priority junction between Colepark Road and Ballyfermot Road may result in left-turning drivers exiting Colepark Road being insufficiently aware of the status of the signals resulting in overshoot into the crossing and vehicular/pedestrian collisions.

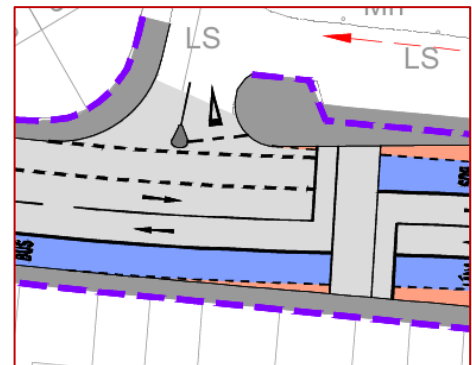
Summary: Right-turning manoeuvres from priority junction where drivers are required to cross multiple lanes could result in unsafe turning manoeuvres and side-on collisions.

Drivers exiting from Colepark Road and wishing to turn right will have to cross multiple lanes. It will be difficult for right-turning drivers to identify safe gaps in the approaching traffic lanes in order to turn right, possibly leading to unsafe manoeuvres and side-on collisions.

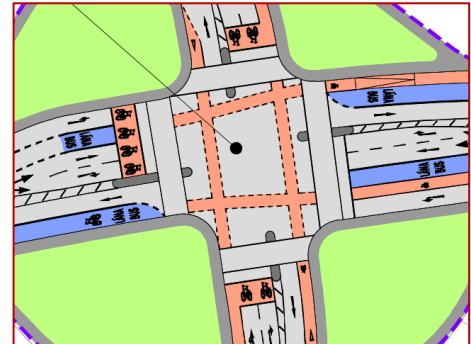
In the absence of measures catering for right-turning cyclists, cyclists may attempt to weave across multiple traffic lanes in order to enter the right-turning lane where they are at increased risk of being struck by a vehicle.

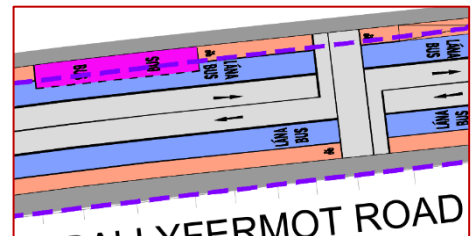
A bus stop is proposed on the northern side of the Ballyfermot Road, east of the Kylemore Road junction. There is a risk that stationary buses at this bus stop could impede visibility for eastbound drivers in the adjacent traffic lane towards the signals at the pedestrian crossing immediately downstream, resulting in approaching drivers being unaware of the need to stop, leading to a failure to stop and overshoot into the crossing resulting in possible vehicular/pedestrian collisions.

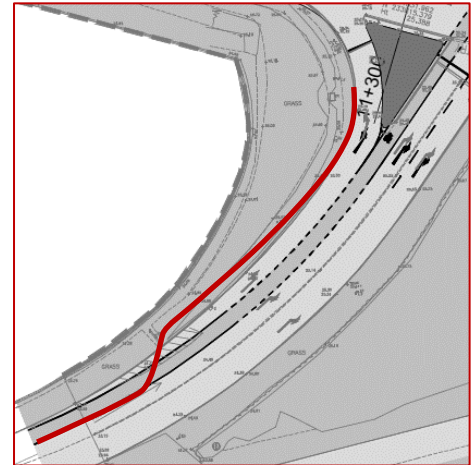
Similarly, the full width of the left-turning lane does not appear to be provided until closer to the splitter island, with the result that vehicles in the left-turning lane may protrude into the adjacent cycle lane and present an obstruction to cyclists who may move into the adjacent traffic lane in order to pass with a resulting increased risk of being struck by a vehicle.

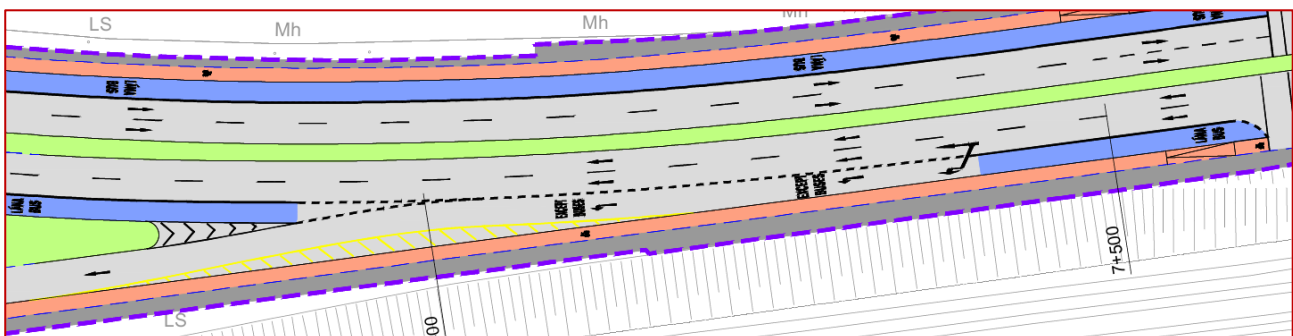
Summary: Increased injury severity outcomes likely should collisions occur between vehicles and cyclists due to higher speeds by left-turning/diverging westbound vehicles at junction of Con Colbert Road & Chapelizod Bypass.

The proposed arrangement for westbound diverging traffic at the Con Colbert Road junction with the Chapelizod Bypass could give rise to high speeds for exiting traffic. The provision of the proposed hatched roadmarkings adjacent to the cycle lane are unlikely to be observed by all drivers, placing cyclists in close proximity to high-speed vehicles with a resulting increased risk of serious injuries should a collision occur.

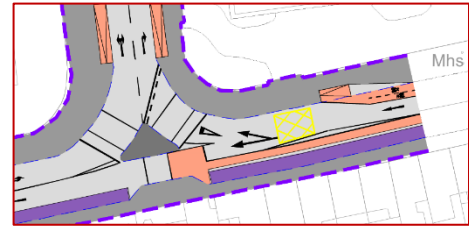
There is an existing two-way cycle track along the northern side of the Inchicore Road between Kilmainham and Memorial Road. It is unclear how westbound cyclists on this two-way cycle track are intended to access the westbound cycle track indicated on the southern side of Inchicore Road on its approach to the Memorial Road junction.

A failure to provide an adequate and safe means for cyclists to travel between the two cycle facilities on Inchicore Road will result in cyclists having to weave across vehicular traffic with an increased risk of being struck.

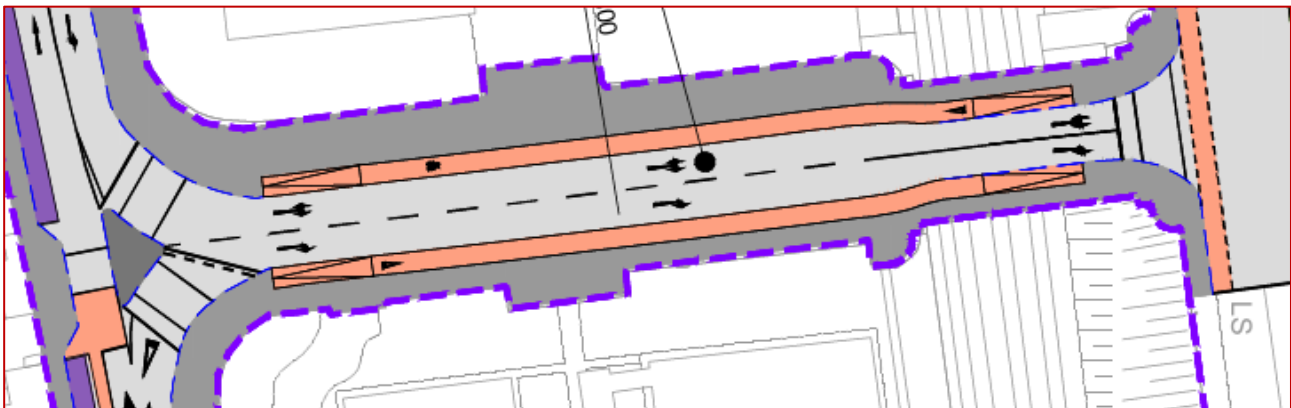
Summary: Proposed cycle facilities on Memorial Road do not adequately interface/integration with cycle facilities on the adjacent road network leading to unsafe manoeuvres by cyclists.

It is unclear how the proposed cycle lanes on Memorial Road interface with the cycle lanes on the adjacent road network, and in particular, how cyclists travel to/from the cycle facilities on the adjacent roads and those on Memorial Road.

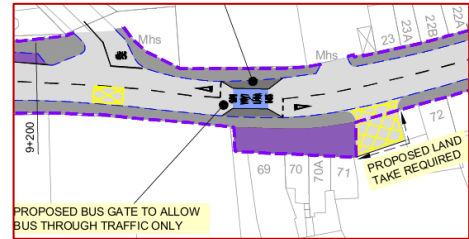
Summary: Absence of u-turn facilities at bus gate on Old Kilmainham Road could result in unsafe u-turn manoeuvres, in particular by large vehicles, with a resulting risk of collisions with other road users.

This could result in unsafe u-turn manoeuvres with resulting risks to other road users, and in particular to vulnerable road users.

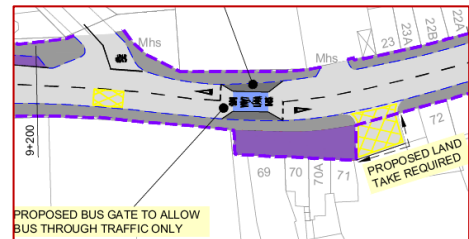
This could result in cyclists entering the bus gate when it is unsafe to do so resulting in them being struck by a bus travelling in either the same direction as the cyclist, or in the opposing direction.
