Liffey Valley to City Centre Core
Bus Corridor

Desktop Safety Review

Document Ref:	P18-083-PSW1-RP-001
----------------------	----------------------------

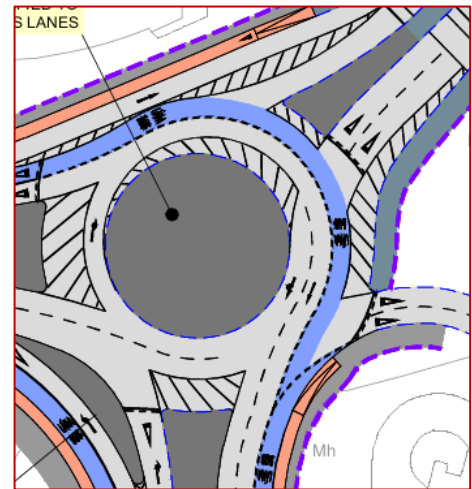
Summary: Complex roundabout junction layout may lead to delays resulting in rash/unsafe manoeuvres and collisions.

These queues may, in turn, lead to driver frustration and rash/unsafe manoeuvres resulting in collisions.

Signalise this junction.

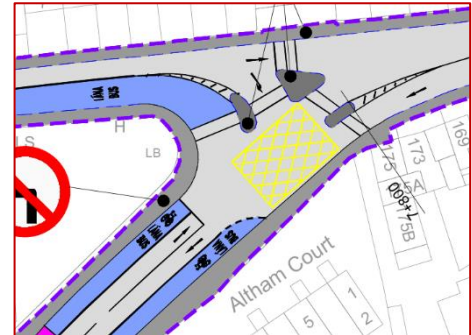
The route for pedestrians wishing to cross Grattan Crescent immediately west of its junction with Sarsfield Road & Inchicore Road is lengthy and may not coincide with the pedestrian desire line at this location.

This could result in pedestrians undertaking uncontrolled crossings of Grattan Crescent with a resulting increased risk of vehicular/pedestrian collisions. This issue is exacerbated by the proximity of the nearby national school, with high numbers of schoolchildren expected to cross at this location.

Provide a signalised crossing of Grattan Crescent at the junction with Sarsfield Road & Inchicore Road.

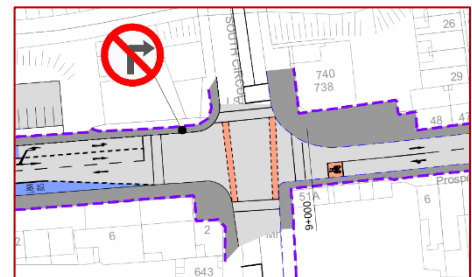
It is proposed to provide a bus gate on Old Kilmainham Road which will significantly alter the existing turning volumes at the South Circular Road junction with Emmet Road & Old Kilmainham Road.

In particular it is likely that the majority of traffic on Emmet Road will now turn left onto the South Circular Road, however the length of the left-turn lane at this location appears relatively short. This could result in significant queues forming, possibly extending into the bus lane thus negating the benefit of the bus lane provision.

Eastbound buses on Emmet Road are likely to wish to proceed straight ahead at the South Circular Road junction, onto Old Kilmainham Road. To do this they must change lane from the bus lane into the straight-ahead lane on the immediate approach to the junction, a manoeuvre that is likely to be compromised should extensive queues form within the left-turning lane on this approach.

This could result in weaving manoeuvres concentrated within a short distance on the immediate approach to the signalised junction with a resulting increased risk of side-swipe collisions.

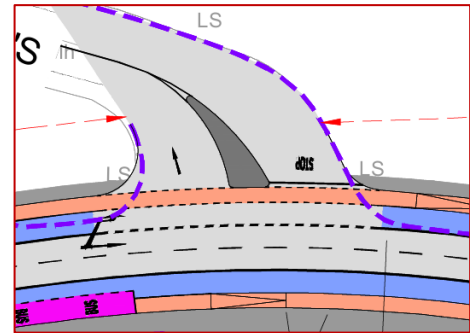
- 5.1 The proposed road layout on St Laurence's Road at its junction with Ballyfermot Road appears to be incorrect, as it does not tie in with the existing carriageway edges and does not show the existing footpaths which it is assumed are to be retained.

It has been assumed that this is a draughting error which will be corrected during subsequent design phases.
